Nozzle REPAIR DN 150

Repair sleeve for glass lined DN 150 central bottom outlet nozzle

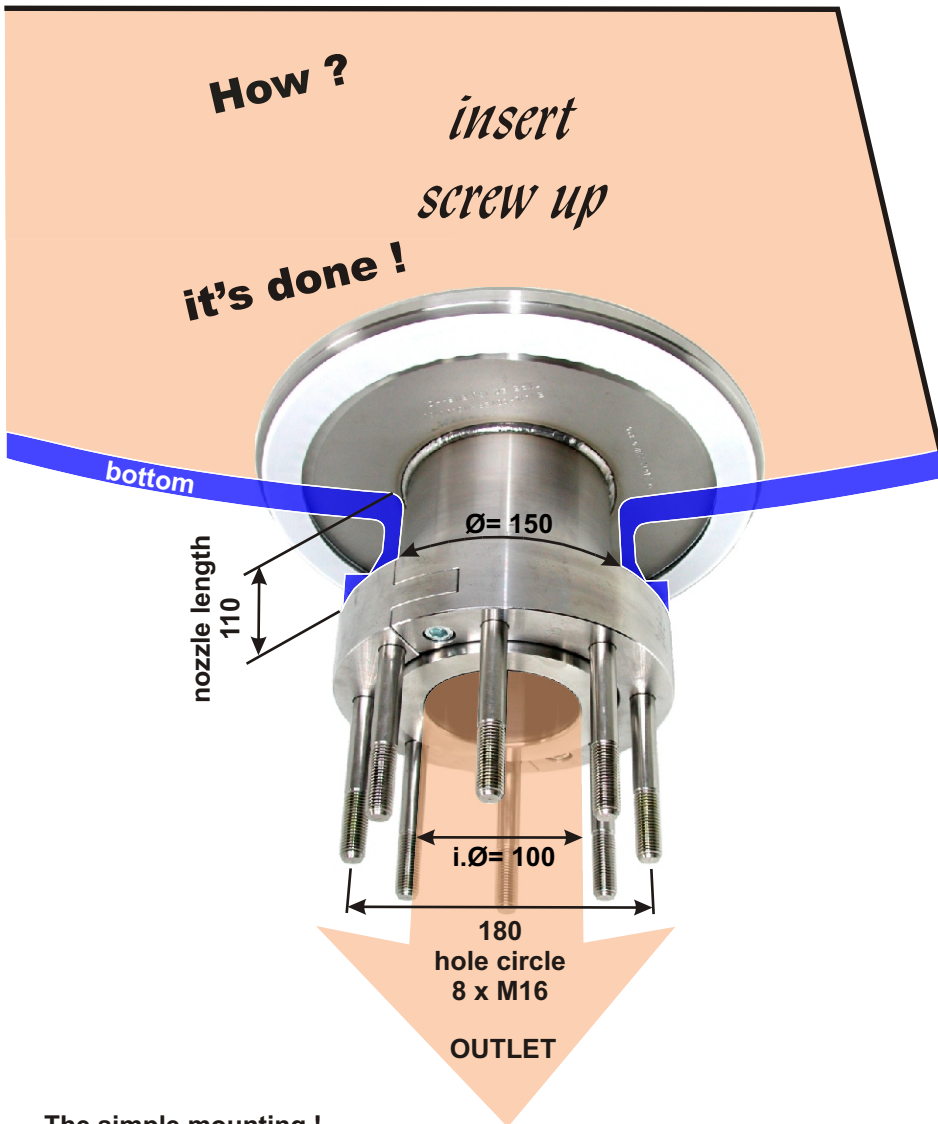
bottom nozzle

Is an enameled bottom outlet nozzle size DN 150 damaged on the inside neck or flange face, it can be repaired by the EC repair sleeve. The sleeve is made of steel and covered with solid PTFE. The mounting is simple, insert the sleeve from inside and screw it up from outside - **no drilling and welding work** is necessary. The new bottom outlet has the size DN 100.

Optional we offer the sleeve in hastelloy or tantalum.
